INTERIM REPORT:
PHASE I OF ROCKY MOUNTAIN ARSENAL
SEWER INVESTIGATIONS

Prepared by
Morrison-Knudsen Engineers, Inc.
Denver, Colorado 80290

April, 1986

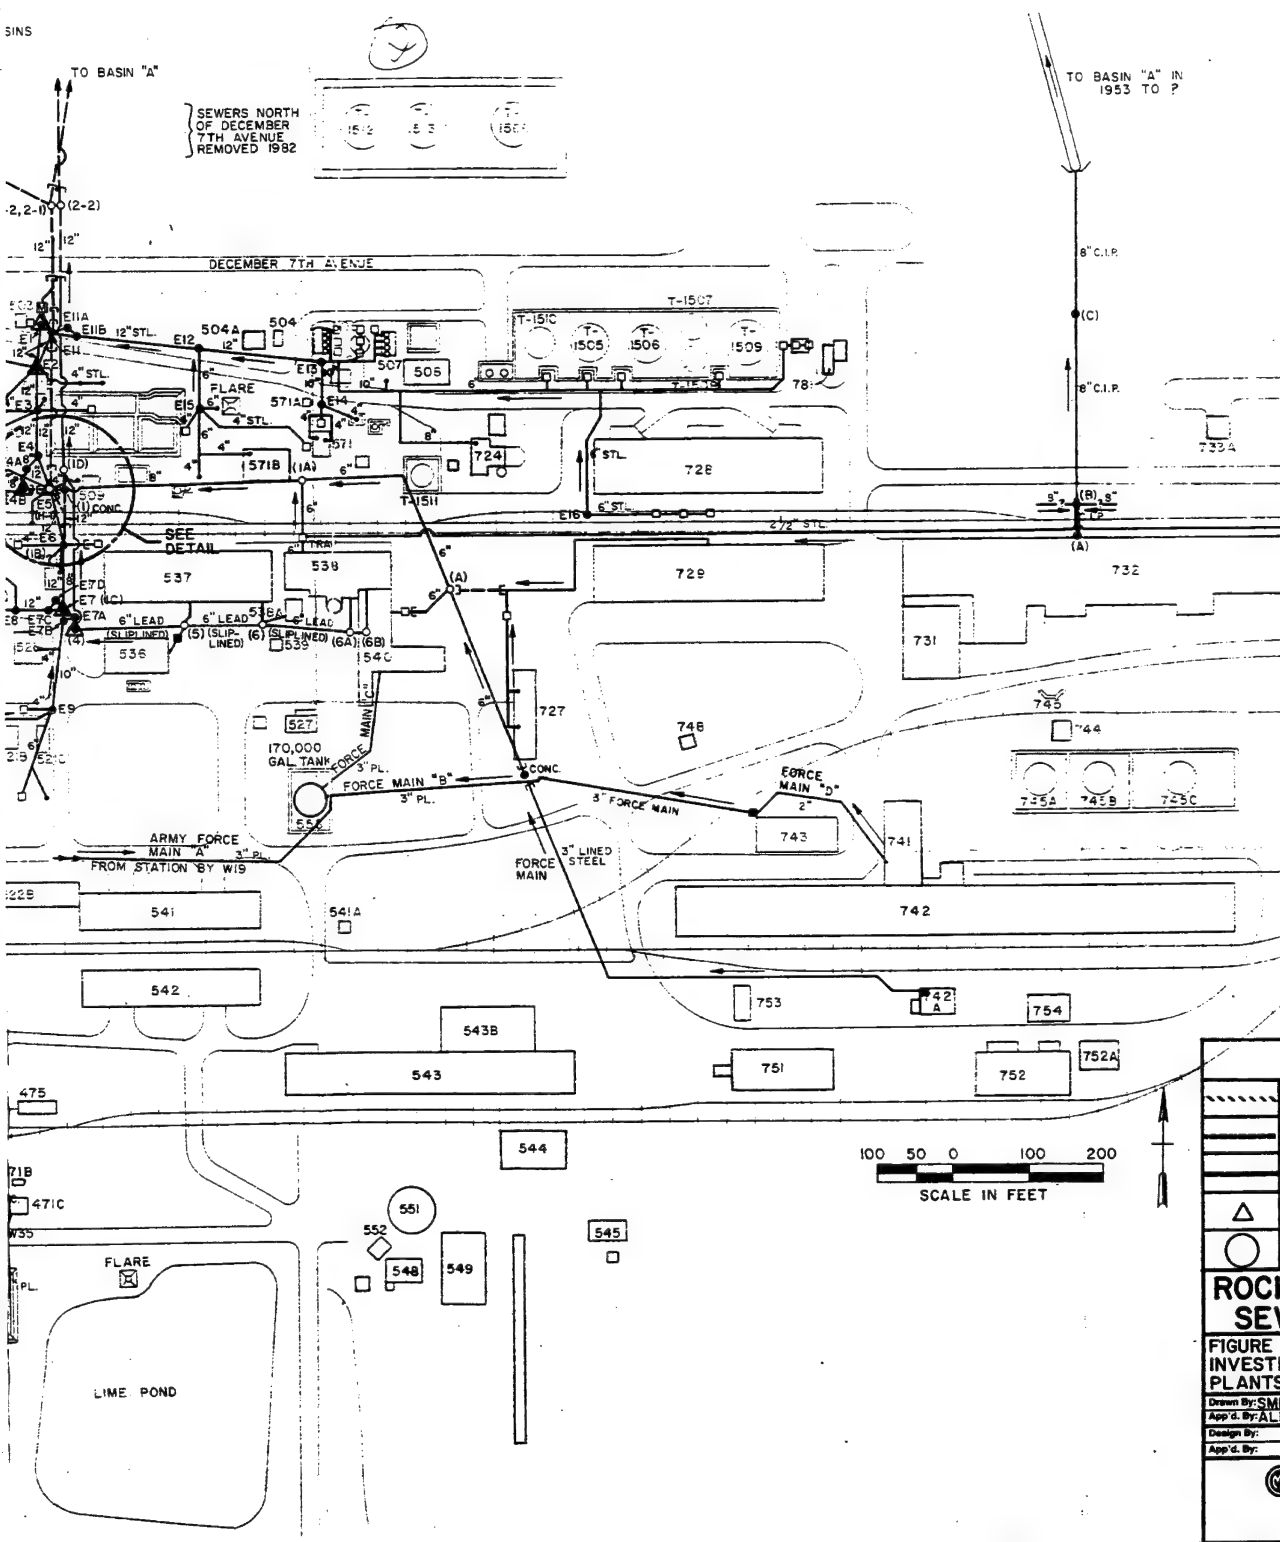
The segments of the RMA sewer systems that were air pressure tested are shown on Figures 3.6, 3.7 and 3.8. All test sites failed to pressurize when air was introduced into the line. The conclusion was reached in the field that further air testing would not produce results that would enable the investigators to distinguish between the relative condition of the various sites tested, and therefore the air testing was halted and the investigating team proceeded with jet cleaning and televising of the lines. Refer to Appendix B for the Air Testing Standard Operating Procedure.

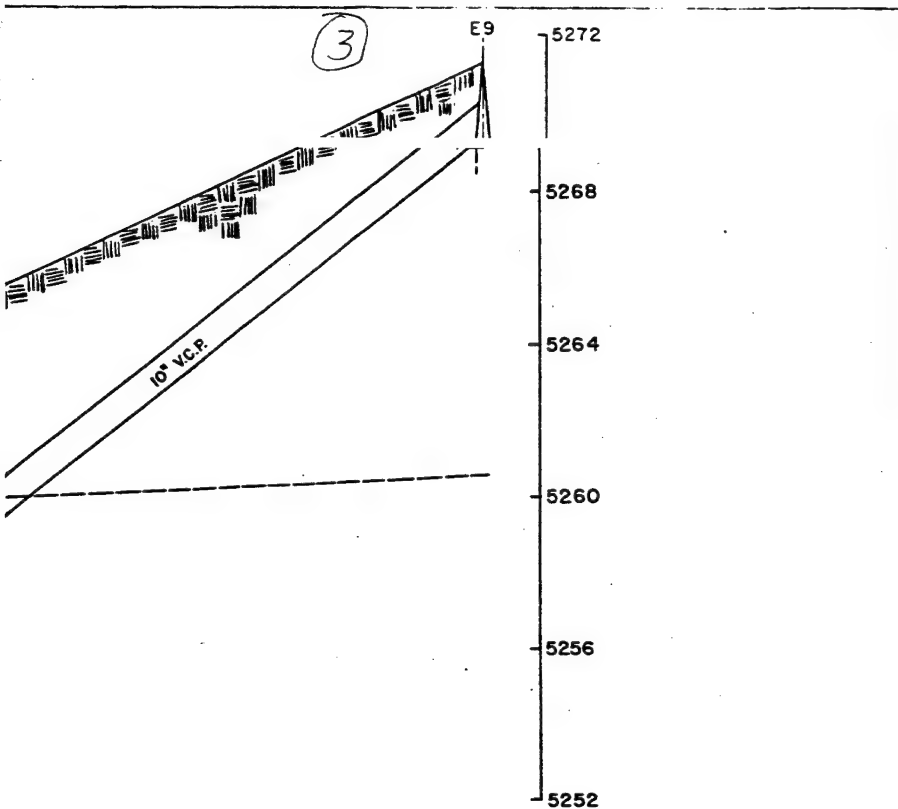
Inspection of the sewer profiles in Figure 3.5A and 3.5B shows that the water elevations in the northern-most manholes along December 7th Avenue (E1 and W1) were over four feet higher than

the adjacent groundwater table during October, 1985. Presumably, wet weather directly recharges the sewers by means of exposed sumps and area drains, and water levels quickly rise in the downstream manholes. Afterwards, the system would equilibrate by exfiltrating into the groundwater. Insufficient information is available at this time to arrive at conclusions on exfiltration and infiltration rates and their distribution along the pipeline.
